Toft kobber A/S

References 2008 - 2025

REFERENCES

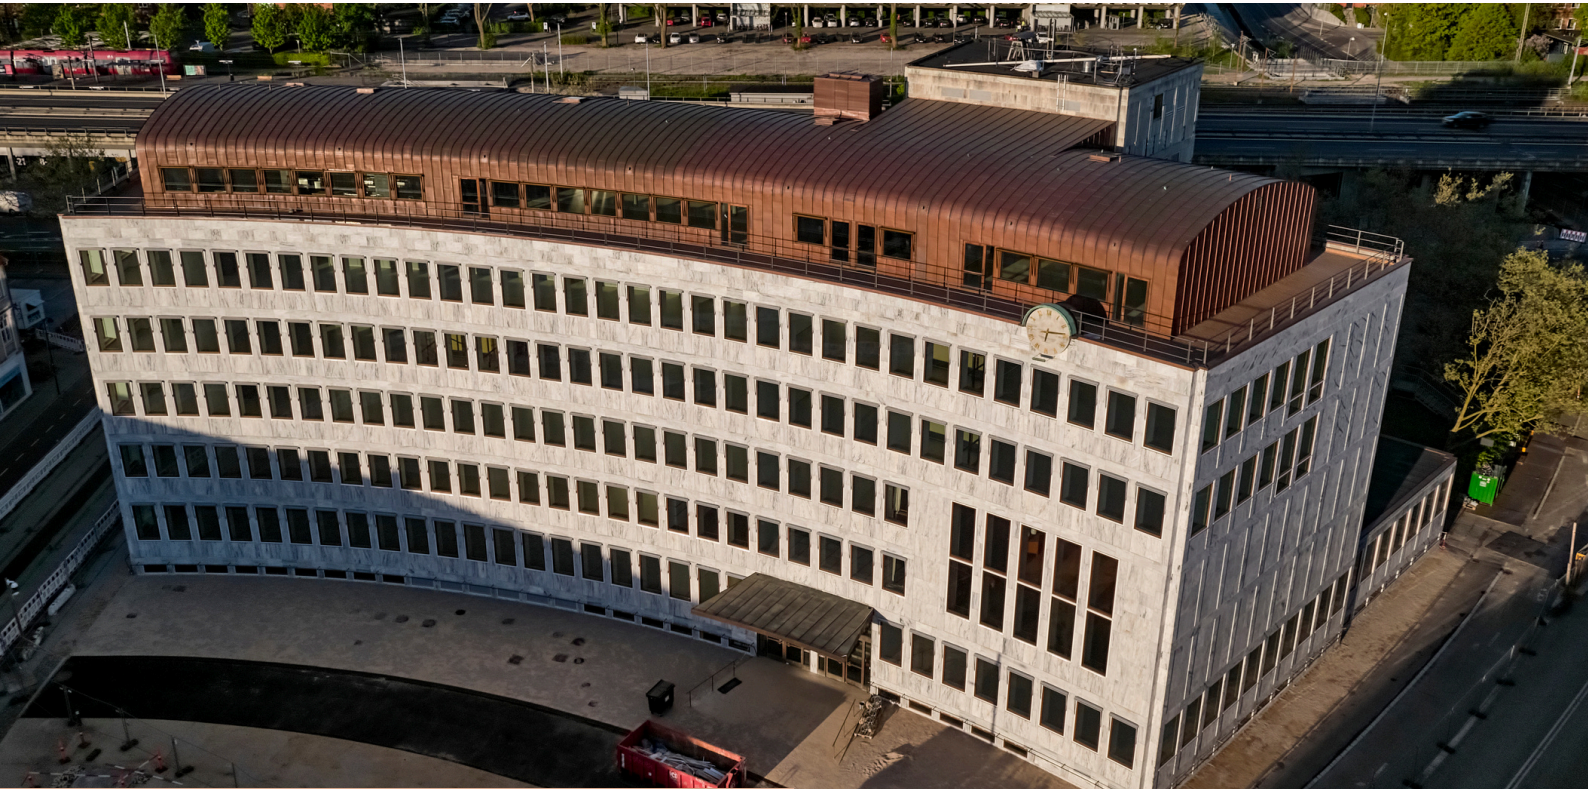
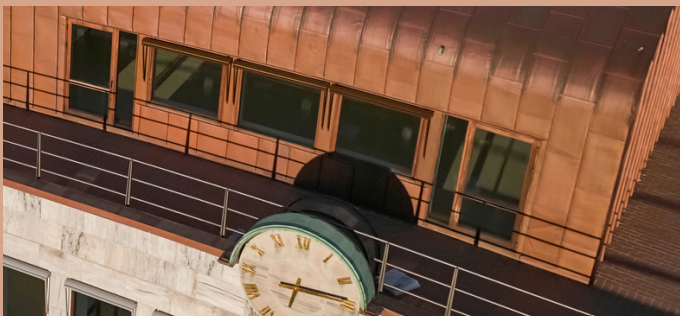
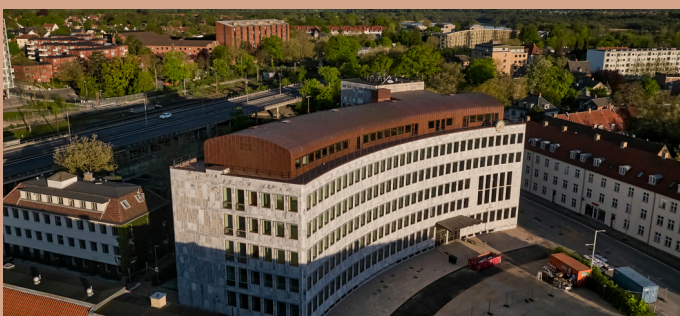
Lyngby Town Hall

New copperroof

In this renovation, the entire town hall was faced with a thorough renovation, and we were involved at the top with the replacement of the copper roof, skylights, ventilation hoods and cornices.

The town hall roof is “banana-shaped” in length, which means that the copper strips are wider on the west-facing side than on the east-facing side due to the curvature.

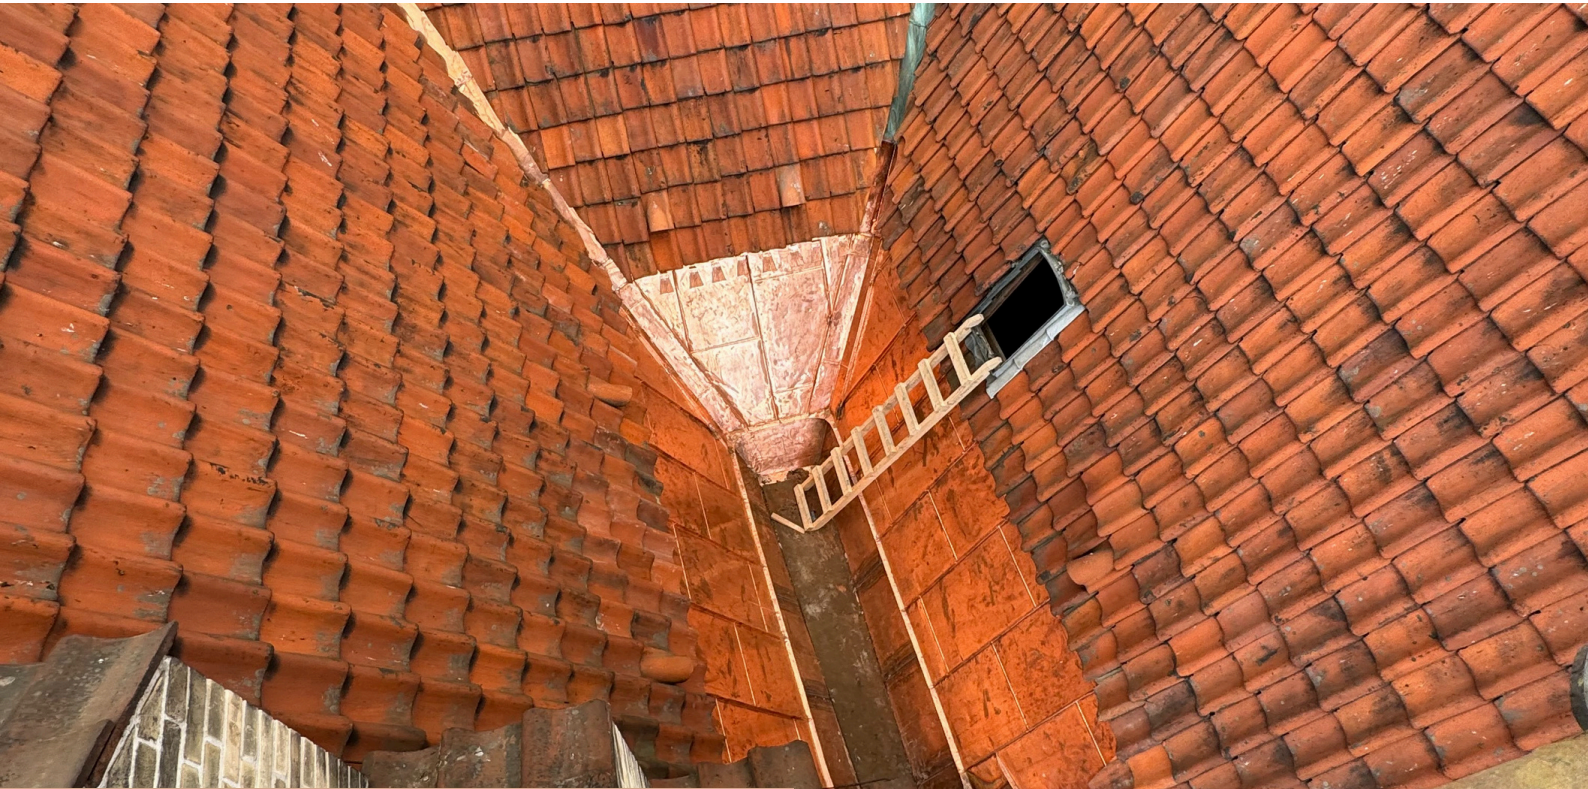
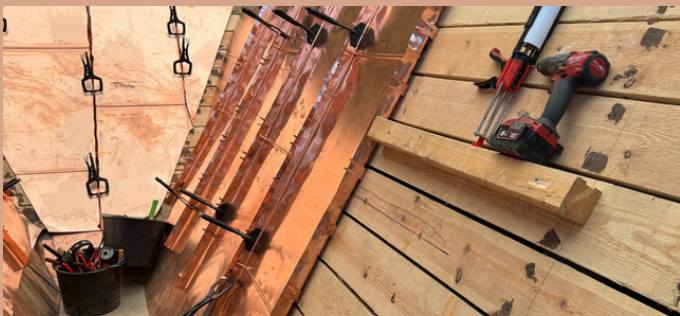
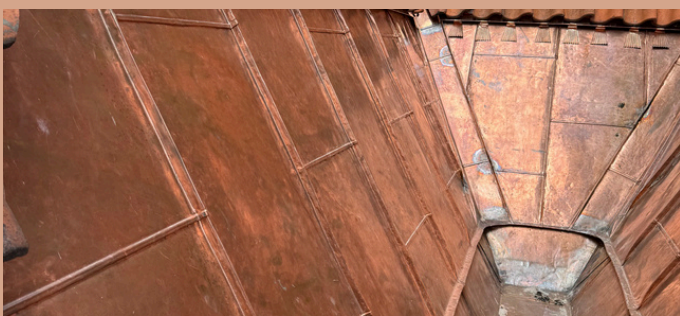
Grundtvigs Church

New copper vessels

The copper vessels are the ones that collect all the water from the church roof and lead down into the downspouts.

Unlike a copper roof, these copper vessels must withstand quite large amounts of water in pressure and strength. Therefore, together with Rønnow Arkitekter, Anders Hald, we have developed a solution that is completely tight.

The solution has been to braze all the seams on the back and use the dovetail slope method.

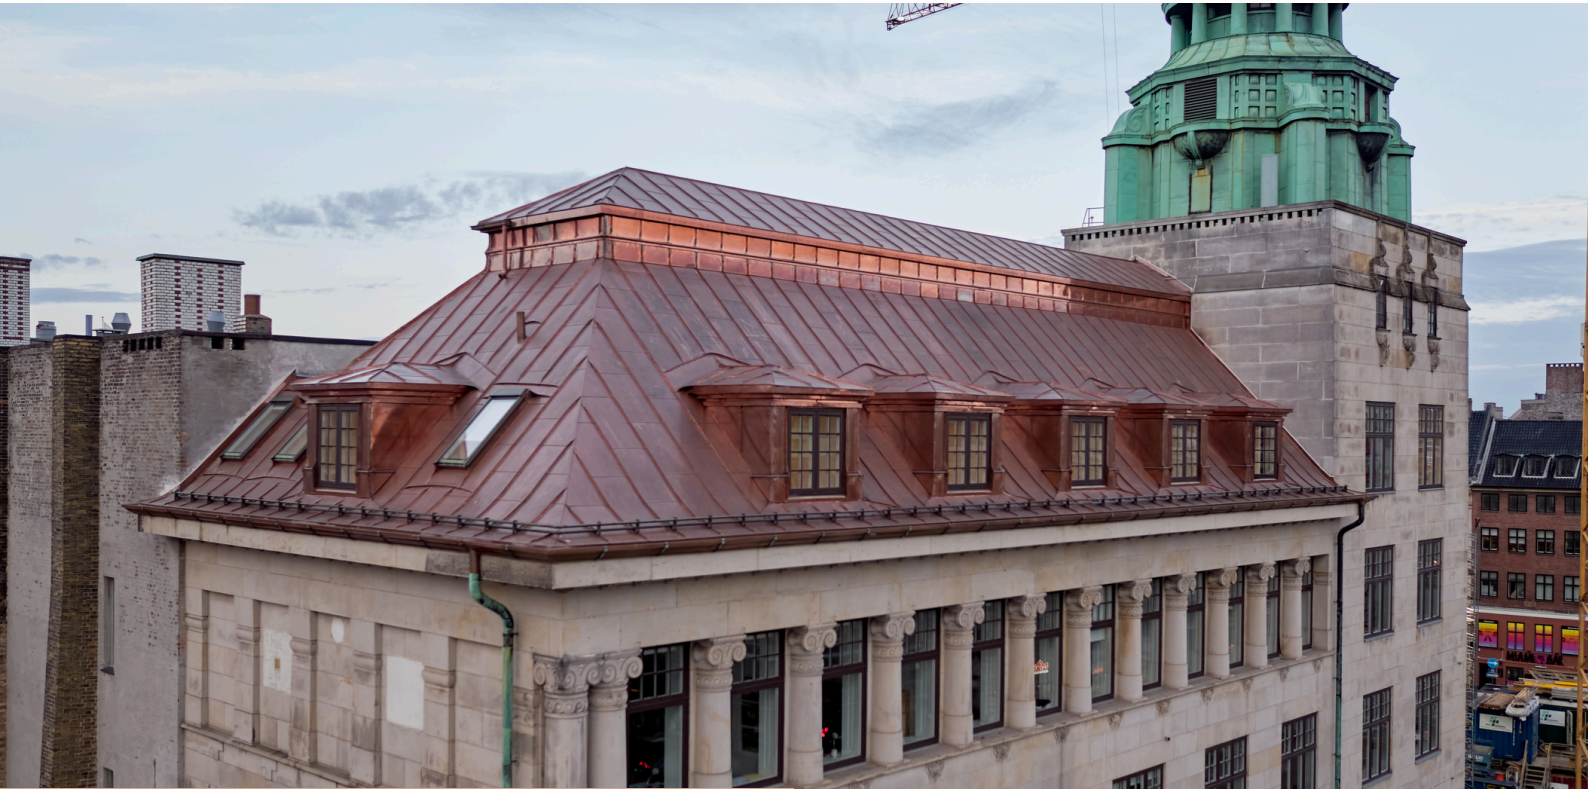
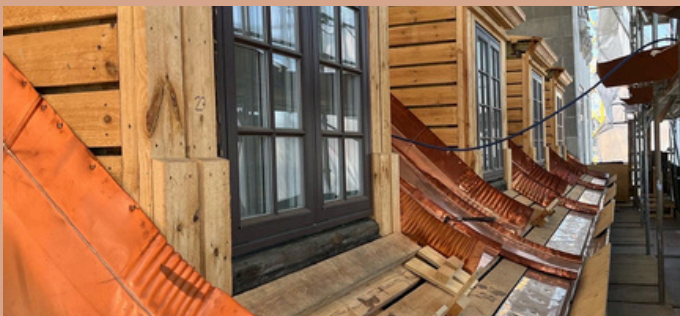
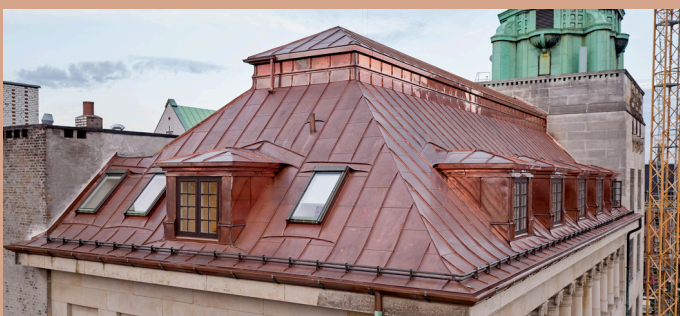
Frederiksberggade 1

Roof and dormers

On Nytorv in Copenhagen, we have replaced the copper roof, 6 dormers, gutters and gutter iron on the city court.

The city court's roof was facing a complete replacement of copper cladding and underlying wooden boards. Originally, the roof had dormer windows facing south, these were not restored.

The existing roof had had problems with condensation, so the task also included that we should incorporate good ventilation into the new structure.

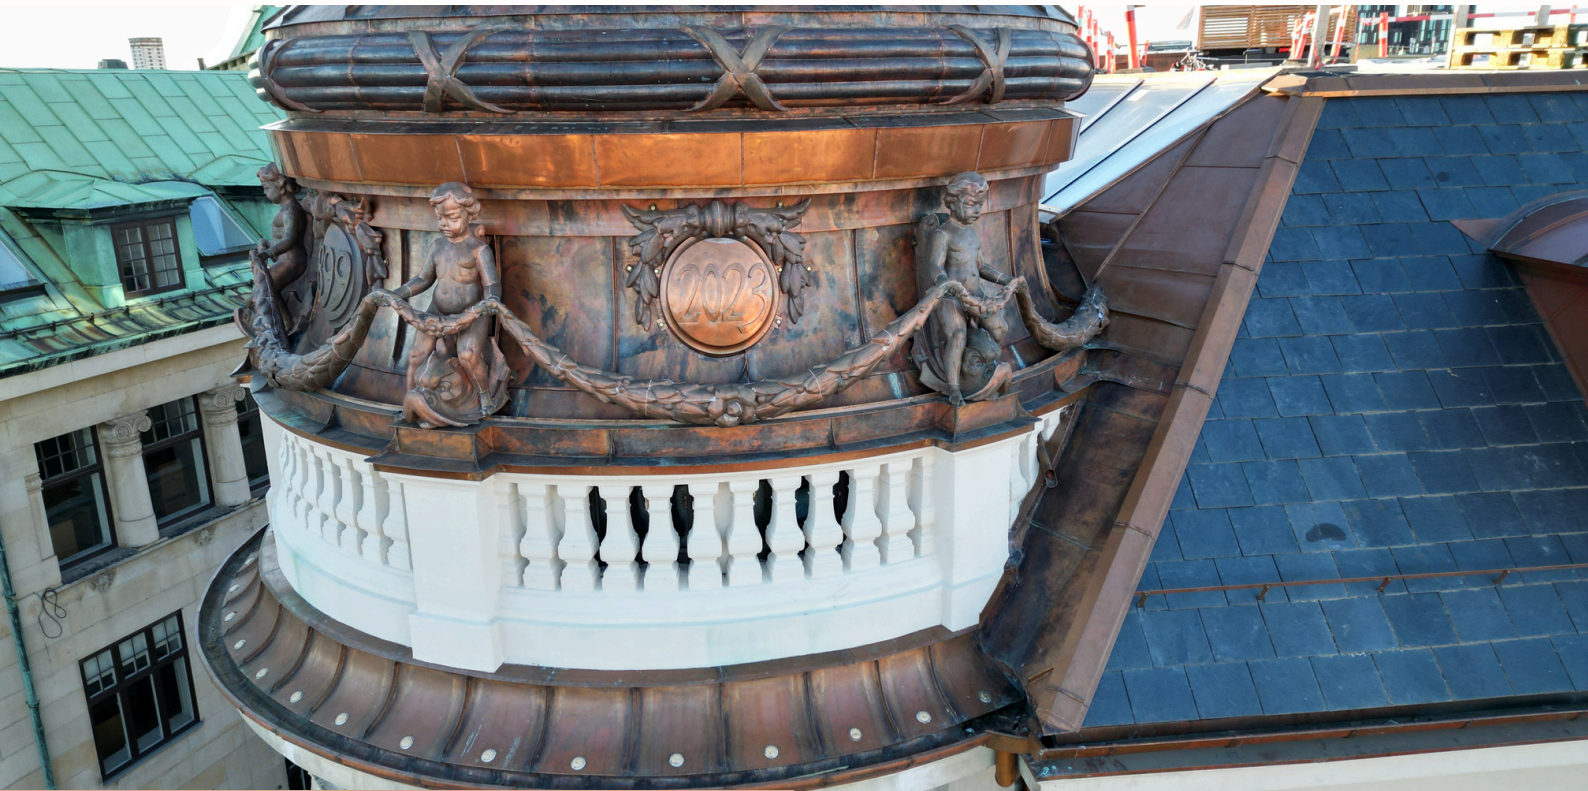
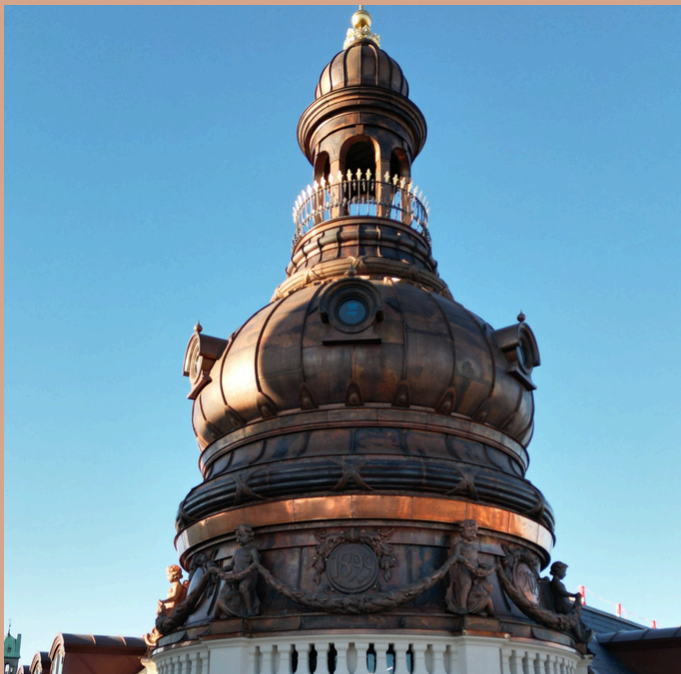
Frederiksberggade 2

Copper tower

The renovation included all the copper work on the tower, as well as copper twigs and a new slate roof. All the parts on the old tower have been dismantled and formed the basis for the molds we will make the new parts from.

The 5 'copper children', the dragons they sit on and the garlands they hold, are the existing ones from the old tower that have been glass blown.

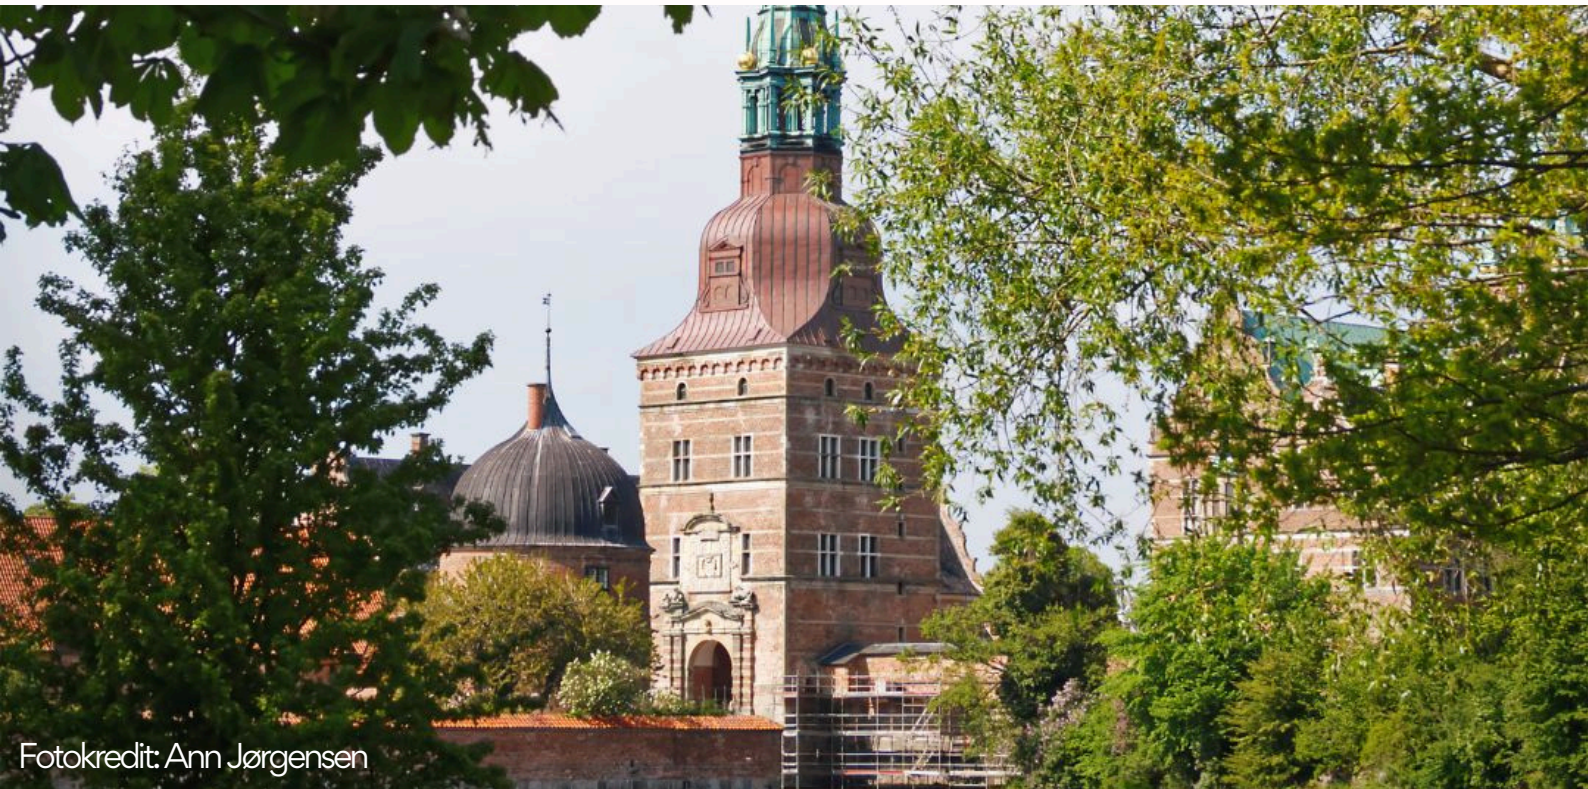
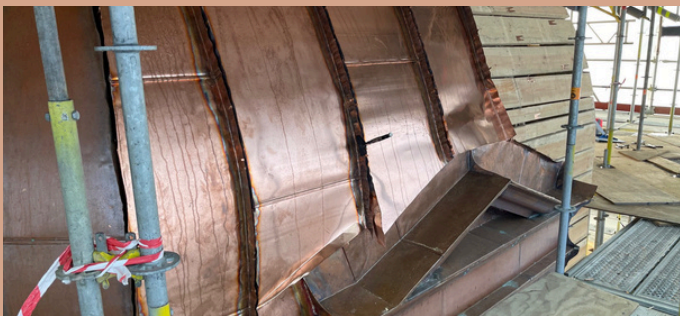
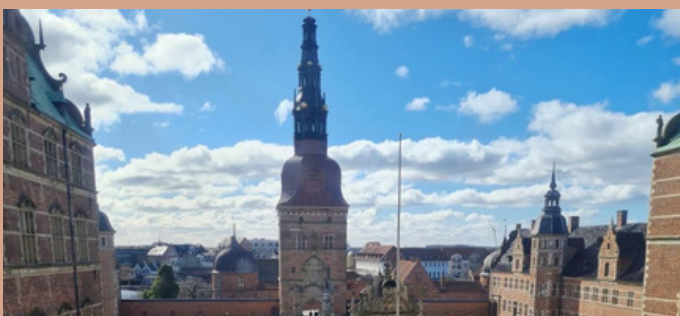
Fangetårnet

Copper tower

The replacement of the prison tower's copper roof itself was a task that suited us very well, as we have extensive experience in the old type of copper.

The Danish Agency for Palaces and Culture was the client and they were faced with the task of combating the mold in the tower and replacing the old and leaking copper on the tower's roof.

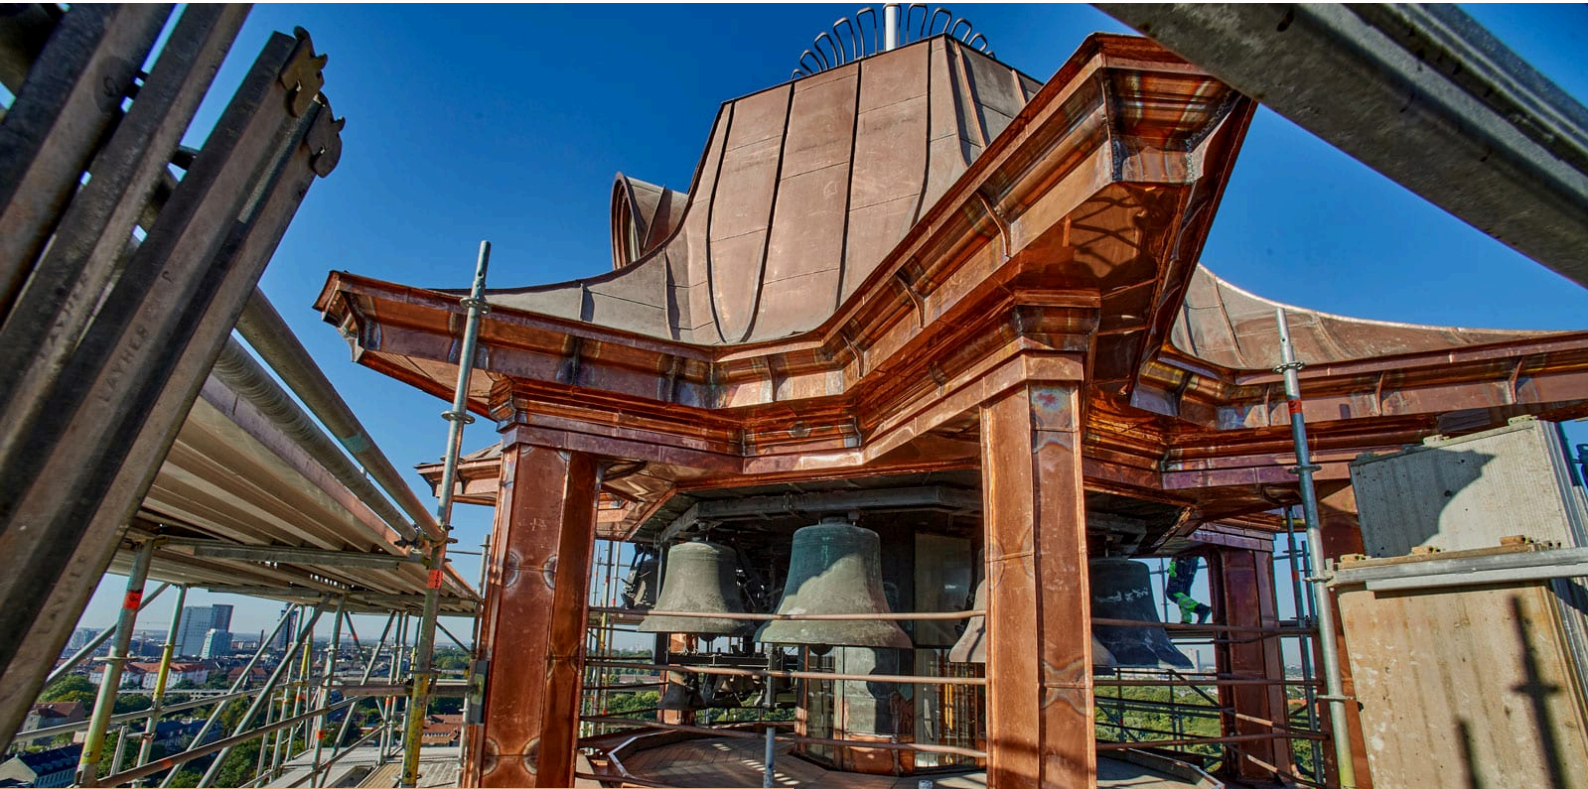
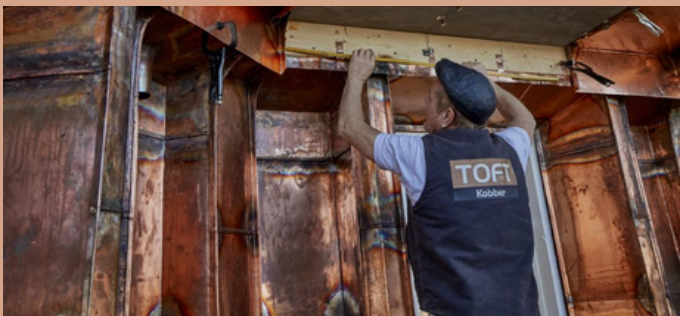
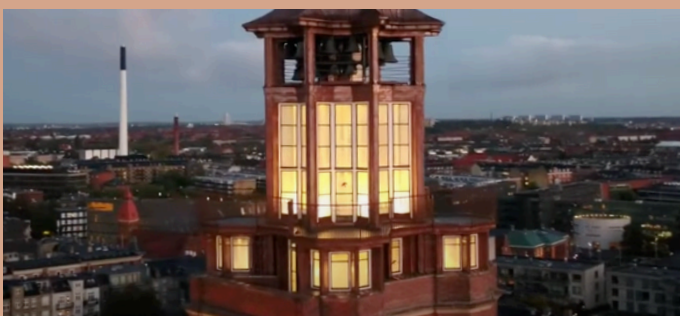
Town hall tower

New copper tower

The copper on top of Frederiksberg City Hall was replaced and appears today as it did when it was built.

There are a total of 12 copper fields covered with blocks on the entire tower - the rest are in obsolete dimensions.

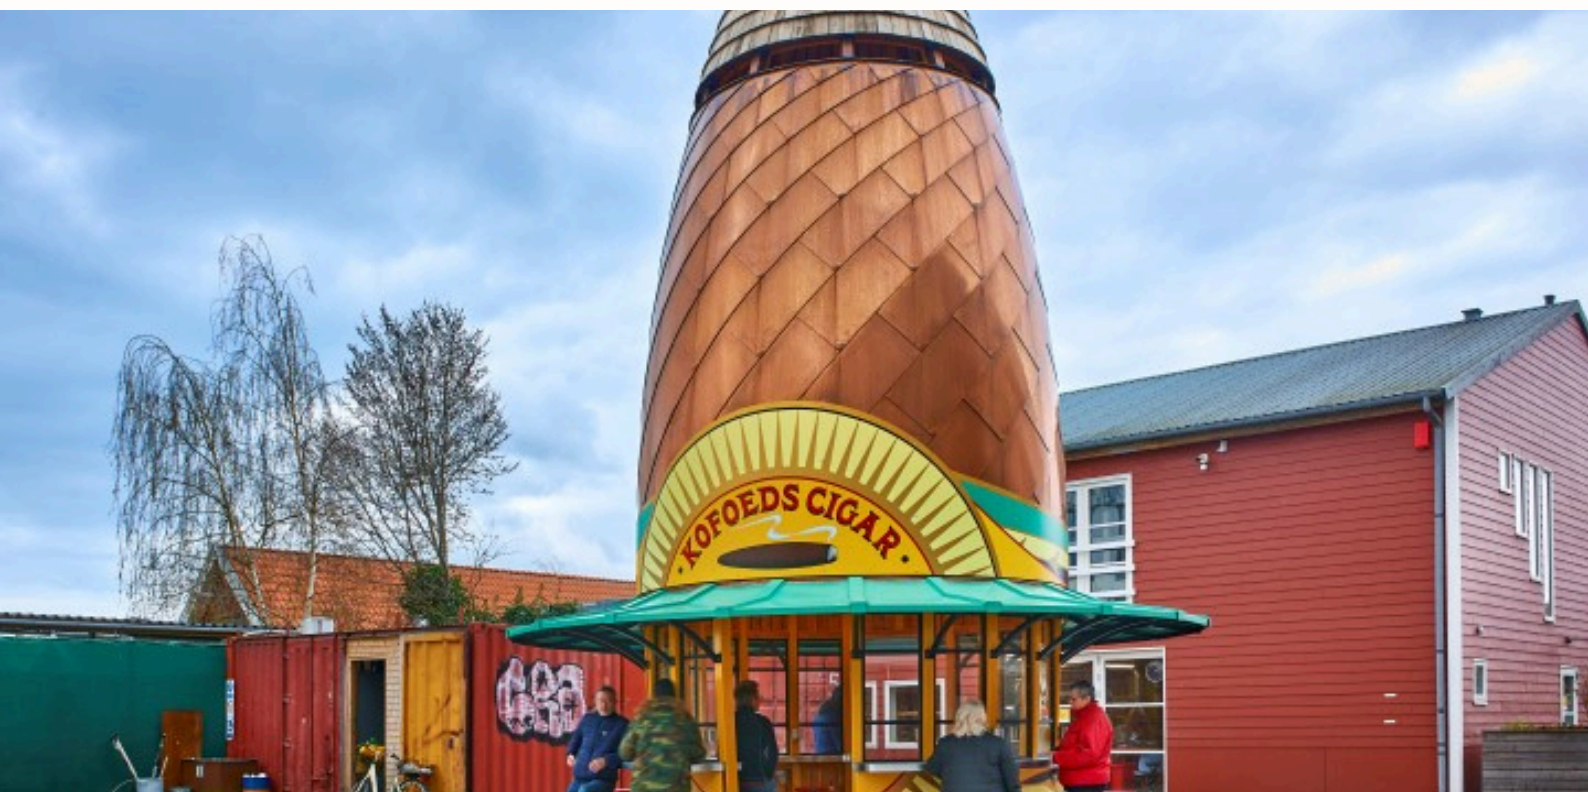
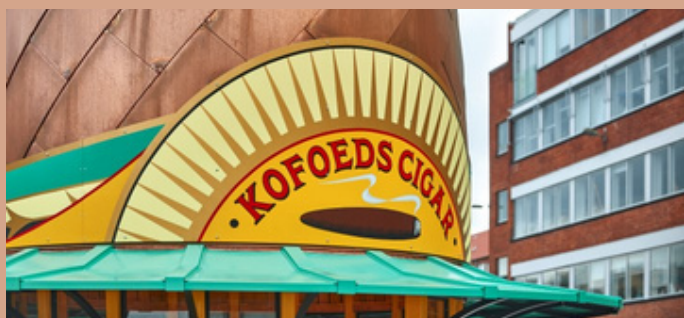
'The Cigar'

New copper cigar

The cigar expression was developed so that the copper came as close as possible to resembling a rolled cigar, within the agreed financial framework.

The cigar is now an outdoor smoking shed that students and teachers can use.

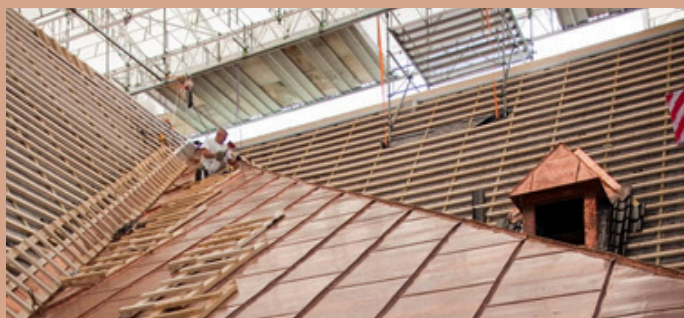
Vor Frelser church

New copperfoof

On the 4 areas of the roof where there is copper, the old green roof was installed and replaced.

In addition, 16 copper rafters in the tiled roof were renovated, new ventilation hoods and vents, stern, gutters and downspouts were installed on the entire roof - all done by hand.

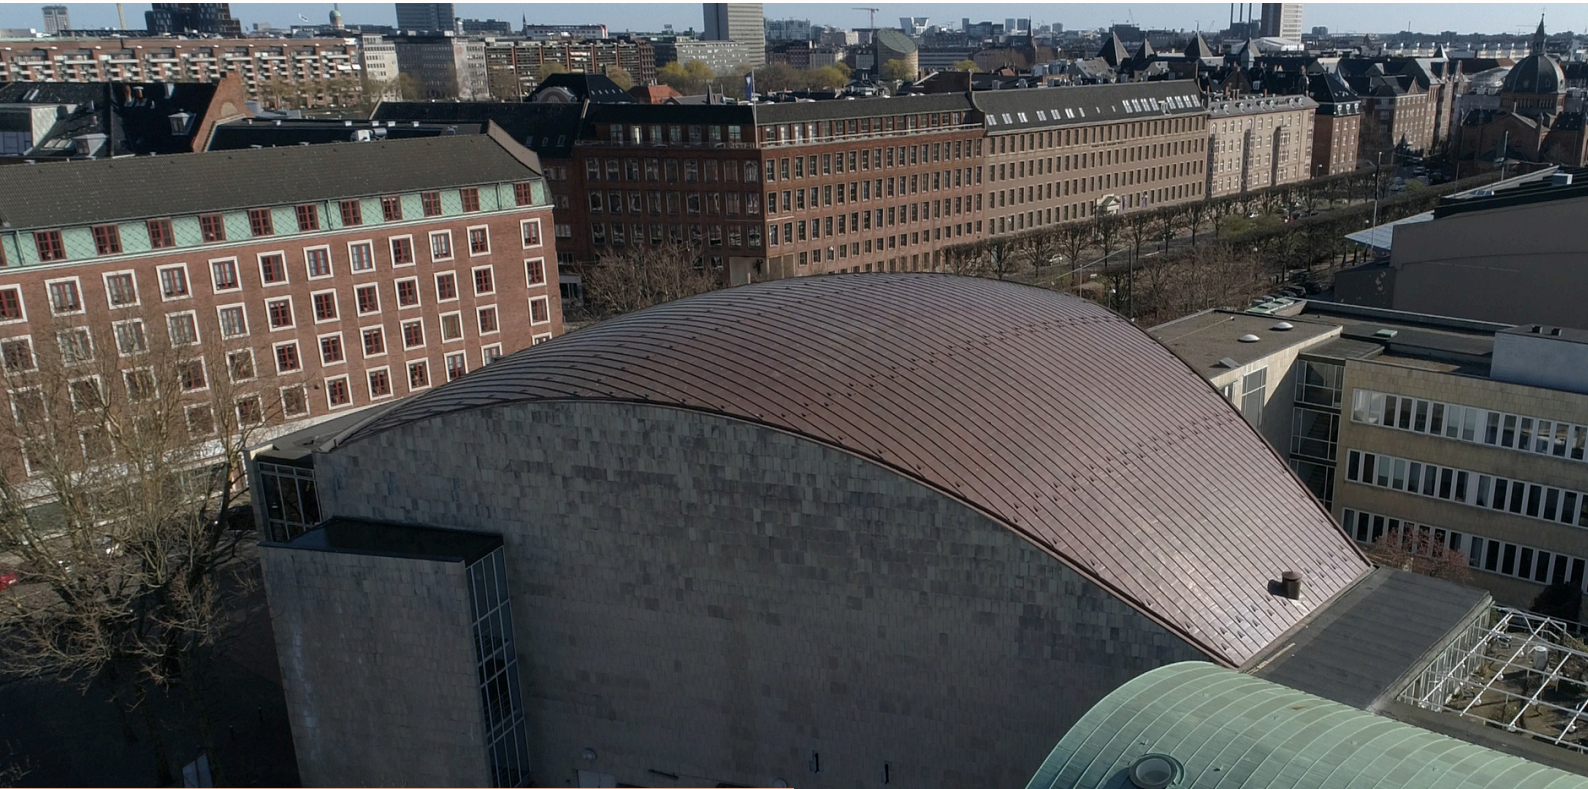
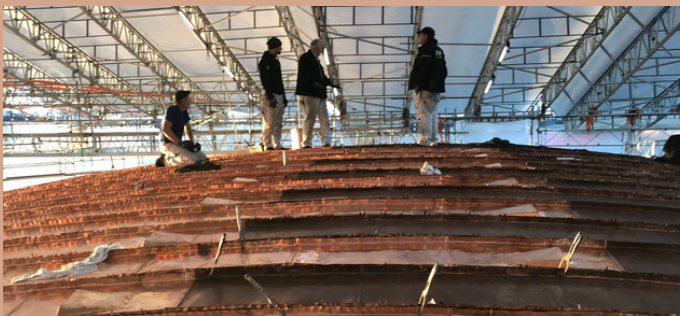
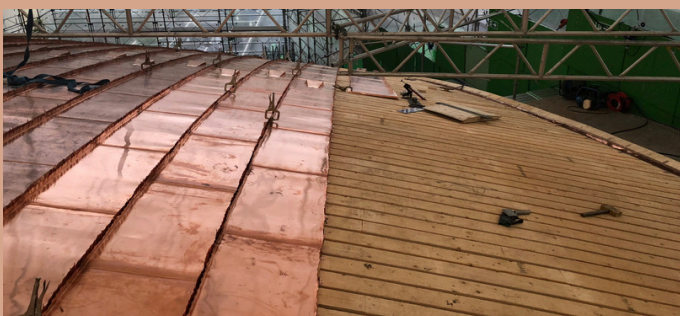
Concert Hall Roof

New copperroof

At the old Radio House, now the Royal Danish Academy of Music, on Rosenørns Allé in Frederiksberg, water was leaking into the concert hall through the existing roof, close to where the organ stood.

The roof is doubly curved. It curves both lengthwise and crosswise.

This places extremely high demands on the execution, as the copper strips must be bent together at an angle.

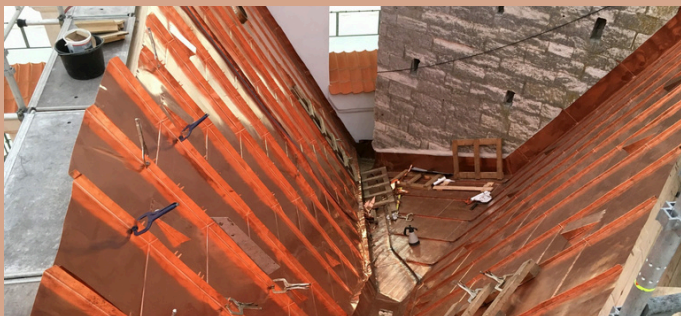
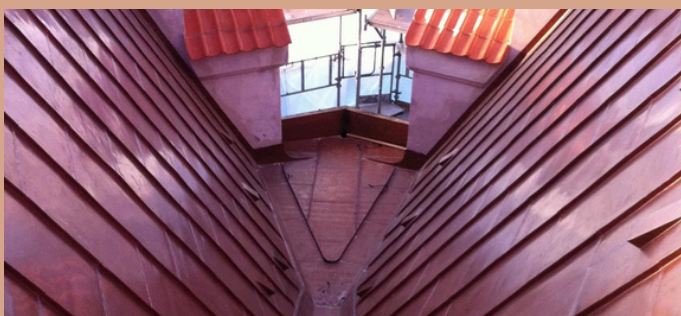
Sct. Katharina Church

New copperroof

The octagonal (8-sided) beautiful Sankt Katharina Church was in need of replacing the copper roof, underlayment, and downspouts.

This was the old copper roof we came across, without any ventilation of any kind, and at the same time the roof had lost its wooden underlayment.

As you can probably see from the pictures, it was a big and challenging task. The roof surfaces were high, very steep and difficult to access with a sloping gutter.

We had to rethink the solution with the bottom tanks, as previously there had been rot damage under the copper.
